**Flood Control Project Maintenance  
Levee Inspections**

**Fall 2018 Levee Maintenance Deficiency Summary Report**

**Sacramento River Basin**

**Flood Control Project Maintenance  
Levee Inspections****LMA District Cover Sheet****Fall 2018 Levee Inspection Results****Reclamation District No. 0003 Grand Island**

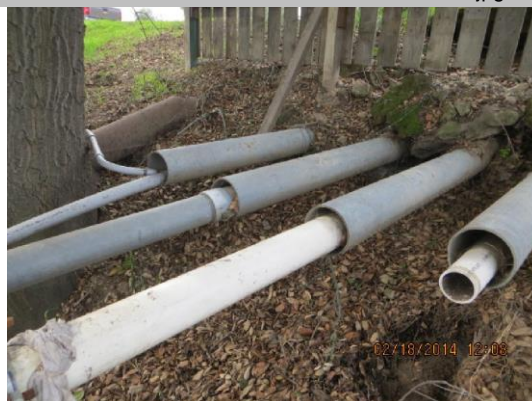
Photo 3 of 3 : UCIP\_FA\_2018\_30353\_55825.jpg

Electrical conduit visible at WS shoulder at 6-inch conduit it is sleeved through.

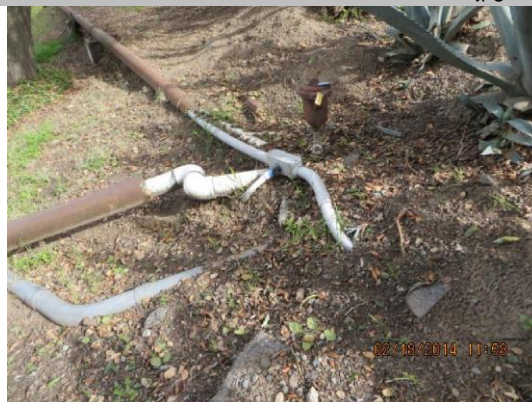
Photo 1 of 2 : UCIP\_FA\_2018\_30356\_55833.jpg

Comment Code						
Inspector Comment						
FS_ID:30356 DS_ID:22357 EP_NO: 16053 Repair Type: Non-Urgent Crossing Status: Found UCIP Comments: Annular space not grouted. FIELD_STRUCT_DESC: 3 of 4: 6-inch galvanized iron water line conduit through the levee, 3 feet below the crown. 4.5-inch polyvinyl chloride (PVC) water line is sleeved through the 6-inch conduit. Vent on the landside (LS) slope. Backflow preventer with two shutoff valves visible on the waterside (WS) shoulder. (Plans to install four 6-inch pipe casings through the levee authorized under Permit No. 16053, 1993 - Vollman-Clark Ranch, DCC Engineering Company, Inc). FS Date: 2/18/2014

Vent or siphon breaker visible on LS shoulder along with 4.5-inch PVC waterline.

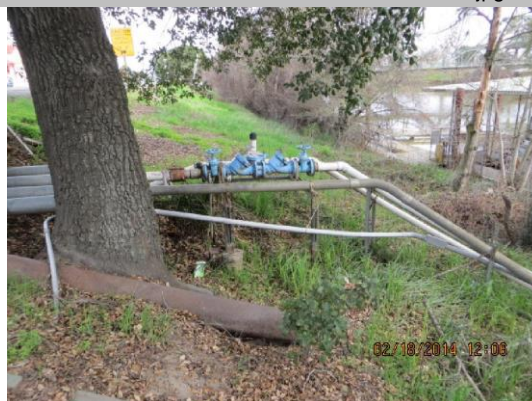
Photo 2 of 2 : UCIP\_FA\_2018\_30356\_55832.jpg

Blue backflow preventer with two shutoff valves visible on WS shoulder.

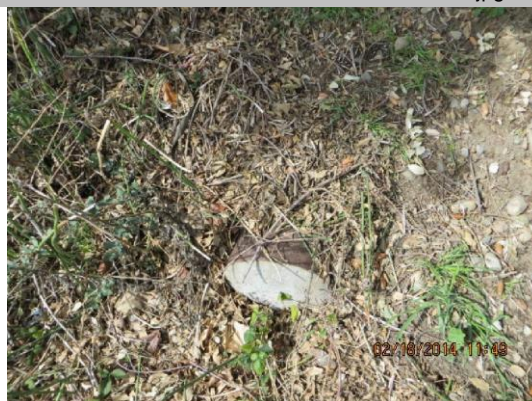
Photo 1 of 3 : UCIP\_FA\_2018\_30345\_55789.jpg

Comment Code						
Inspector Comment						
FS_ID:30345						
DS_ID:22292						
EP_NO: N/A						
Repair Type: Non-Urgent						
Crossing Status: Found						
UCIP Comments: Depression over pipe at crown may indicate pipe is failing.						
FIELD_STRUCT_DESC: *ABANDONED* 12-inch welded steel irrigation discharge pipe through the levee, invert elevation 5 feet below the crown. Pipe was cut off and filled with concrete on the waterside (WS) slope. Pipe was cut off and left open on the WS end. (Plans to install a 7.5-horsepower angle mounted irrigation pump and a 12-inch, 10-gauge welded steel discharge pipe through the levee authorized under Permit No. 5428, 1966 - Grand Island Farms). [Additional Reference(s): DWR Levee Log, 1993, 10-inch pipe referenced. USACE Sacramento O&M Manual 104, February 1960, (RM 26.80), 10-inch pipe referenced].						
FS Date: 2/18/2014

Pipe with concrete fill on WS slope.

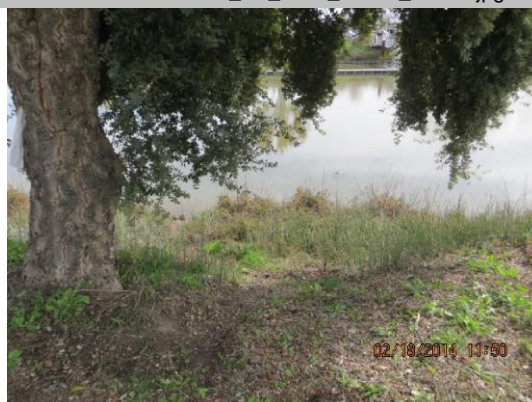
Photo 2 of 3 : UCIP\_FA\_2018\_30345\_55788.jpg

Pipe visible just downstream and downhill from Cork Oak on WS shoulder.

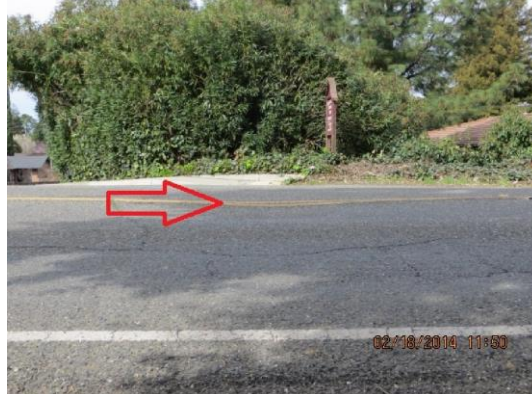
Photo 3 of 3 : UCIP\_FA\_2018\_30345\_55787.jpg

Item	DWR UCIP Field Study			38.243865 °	38.243865 °	
				-121.514241 °	-121.514241 °	
DWR ID	22292					
Comment Code						
Inspector Comment						
FS_ID:30345 DS_ID:22292 EP_NO: N/A Repair Type: Non-Urgent Crossing Status: Found UCIP Comments: Depression over pipe at crown may indicate pipe is failing. FIELD_STRUCT_DESC: *ABANDONED* 12-inch welded steel irrigation discharge pipe through the levee, invert elevation 5 feet below the crown. Pipe was cut off and filled with concrete on the waterside (WS) slope. Pipe was cut off and left open on the WS end. (Plans to install a 7.5-horsepower angle mounted irrigation pump and a 12-inch, 10-gauge welded steel discharge pipe through the levee authorized under Permit No. 5428, 1966 - Grand Island Farms). [Additional Reference(s): DWR Levee Log, 1993, 10-inch pipe referenced. USACE Sacramento O&M Manual 104, February 1960, (RM 26.80), 10-inch pipe referenced]. FS Date: 2/18/2014

Depression over pipe alignment in crown/roadway.

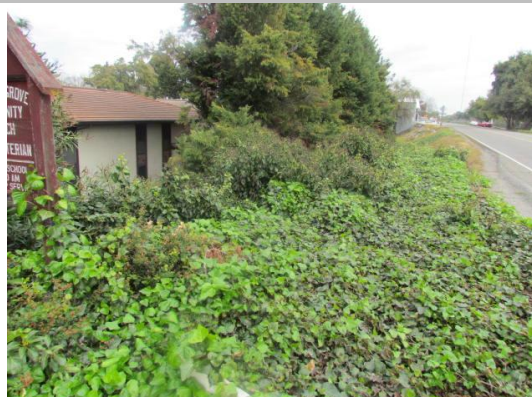
Photo 1 of 2 : FA\_2018\_RD0003\_25\_83\_20180925\_00067.jpg

LM Start	11.81	Rating **	M	Issue No.	83
LM End	11.85	Issue Type +	En	Location *	LS
Category	Earthen Levee			GPS Latitude/Longitude	
				Start	End
Item	Vegetation			38.243915 °	38.244392 °
				-121.514254 °	-121.513740 °
DWR ID	DWR_RD0003_02_s_2012_83				
Comment Code					
V6 : Landscaping					
Inspector Comment					
Dense landscaping on landside slope.

Looking north at dense landscaping on landside shoulder and slope.

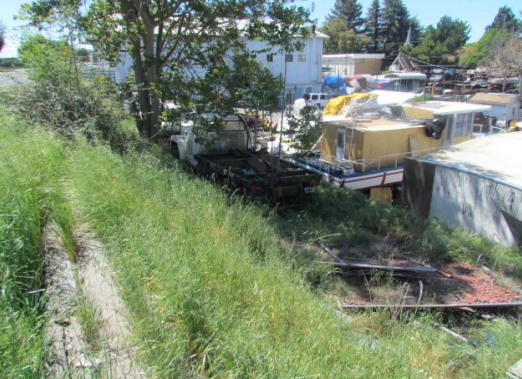
Photo 1 of 2 : FA\_2018\_RD0003\_25\_86\_20180925\_00071.jpg

Looking south at abandoned vehicles and material on landward slope

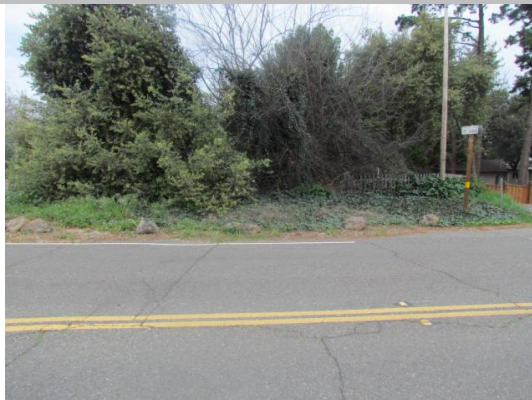
Photo 2 of 2 : FA\_2018\_RD0003\_25\_31\_20180925\_00030.jpg

LM Start	12.01	Rating **	U	Issue No.	31 (cont)
LM End	12.08	Issue Type +	En	Location *	LS
Category	Earthen Levee			GPS Latitude/Longitude	
				Start	End
Item	Vegetation			38.246310 °	38.247332 °
				-121.512157 °	-121.511773 °
DWR ID	DWR_RD0003_02_s_2012_31				
Comment Code					
V6 : Landscaping					
Inspector Comment					
Landscaping and new wooden fence on landside slope.

Looking west at dense landscaping on landside shoulder and slope.

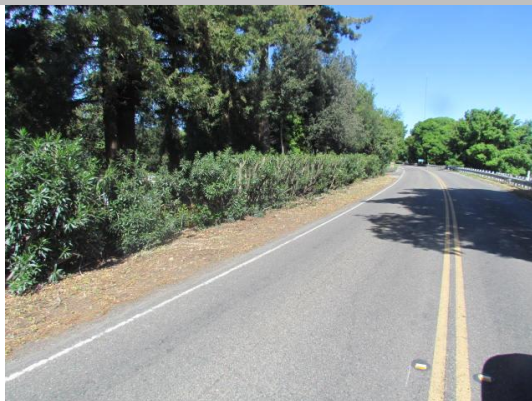
Photo 1 of 2 : FA\_2018\_RD0003\_25\_32\_20180925\_00031.jpg

LM Start	12.04	Rating **	M	Issue No.	32
LM End	12.18	Issue Type +	En	Location *	LS
Category	Earthen Levee			GPS Latitude/Longitude	
				Start	End
Item	Vegetation			38.246802 °	38.248682 °
				-121.511956 °	-121.511657 °
DWR ID	DWR_RD0003_02_s_2012_32				
Comment Code					
V6 : Landscaping					
Inspector Comment					
Oleander partially blocking view of levee on landside slope.

Looking northwest at trimmed oleander partially blocking view of landward slope. (Spring 2015)

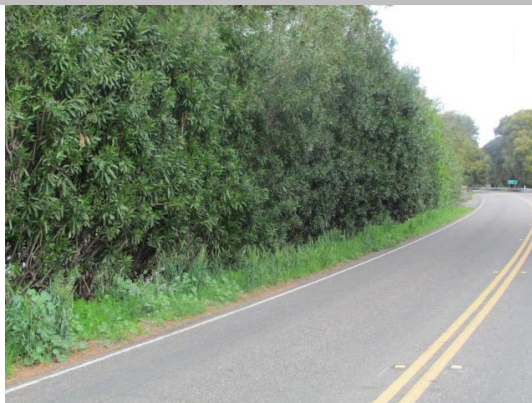
Photo 2 of 2 : FA\_2018\_RD0003\_25\_32\_20180925\_00032.jpg

Looking northwest at oleander on landside shoulder. (Spring 2014)

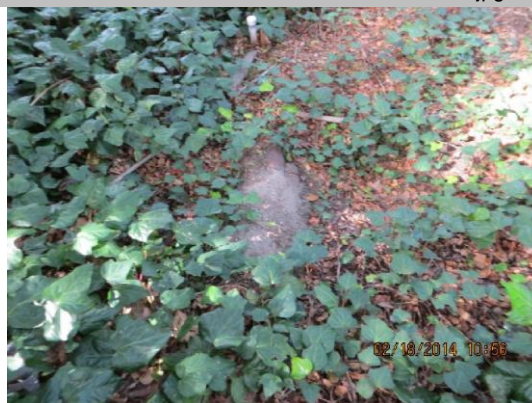
Photo 1 of 3 : UCIP\_FA\_2018\_30306\_55726.jpg

Comment Code						
Inspector Comment						
FS_ID:30306 DS_ID:22296 EP_NO: 2383 Repair Type: Non-Urgent Crossing Status: Found UCIP Comments: Annular space should be grouted. No permit identified for pipes sleeved through irrigation pipe. FIELD_STRUCT_DESC: 6-inch steel irrigation discharge pipe through the levee, 4 feet below the crown. Pump and gate valve on the waterside (WS) slope. A 4-inch pipe is sleeved through the 6-inch pipe. Two conduits are sleeved through the 4-inch pipe: A 1-inch water line and a 1.5-inch electrical conduit provide service to a boat dock, 210 feet upstream from the pump. (Plans for the installation of a pump on the WS slope and a 6-inch discharge pipe through the levee, 4 feet below the crown, authorized under Permit No. 2383, 1956 - James S. and Nancy P. Moser). The 4-inch pipe and two conduits were sleeved through the 6-inch pipe at a later date and likely without a permit. [Additional Reference(s): DWR Levee Log, 1993]. FS Date: 2/18/2014

6-inch pipe visible on LS toe.

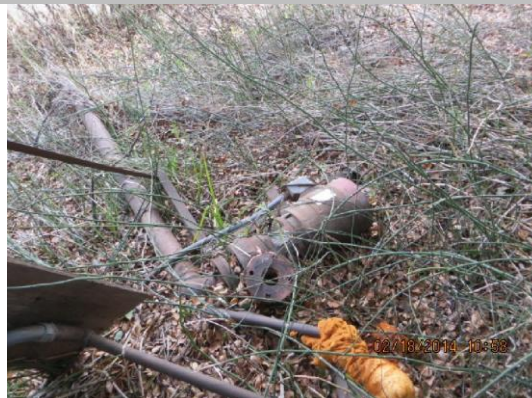
Photo 2 of 3 : UCIP\_FA\_2018\_30306\_55729.jpg

Pipe and pump visible on WS slope.

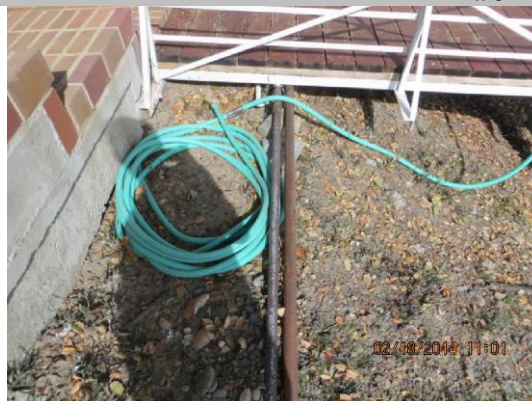
Photo 3 of 3 : UCIP\_FA\_2018\_30306\_55728.jpg

2-steel pipes run parallel to crown on WS slope from pump to boat walkway, 210-feet upstream from pump.

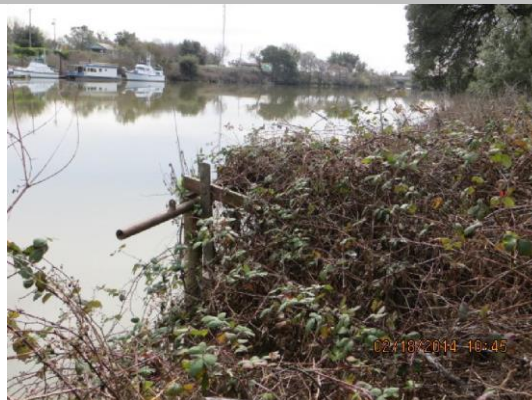
Photo 1 of 3 : UCIP\_FA\_2018\_30305\_55725.jpg

Comment Code						
Inspector Comment						
FS_ID:30305						
DS_ID:22297						
EP_NO: N/A						
Repair Type: Non-Urgent						
Crossing Status: Found						
UCIP Comments: Pump and pipe abandoned and should be done so properly.						
FIELD_STRUCT_DESC: 7-inch steel irrigation discharge pipe through the levee, invert elevation 8.4 feet below the crown. Pump platform visible on the waterside (WS) slope. 1.5-inch steel electrical conduit through the levee at the same location. (H. Town). [Additional Reference(s): DWR Levee Log, 1993, 5-inch pipe referenced. USACE Sacramento O&M Manual 104, February 1960, (RM 27.29), 5-inch galvanized iron pipe referenced].						
FS Date: 2/18/2014

Abandoned pump platform on WS slope.

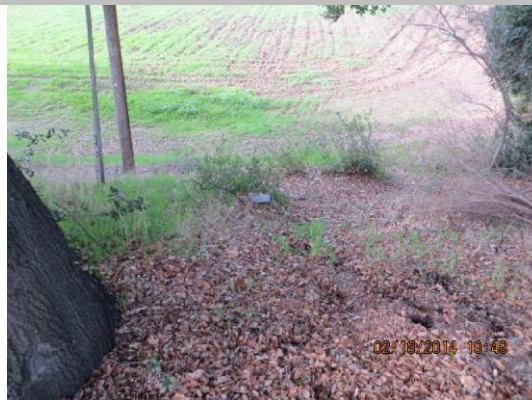
Photo 2 of 3 : UCIP\_FA\_2018\_30305\_55724.jpg

Electrical conduit, pole, and pipe remnants on LS slope.

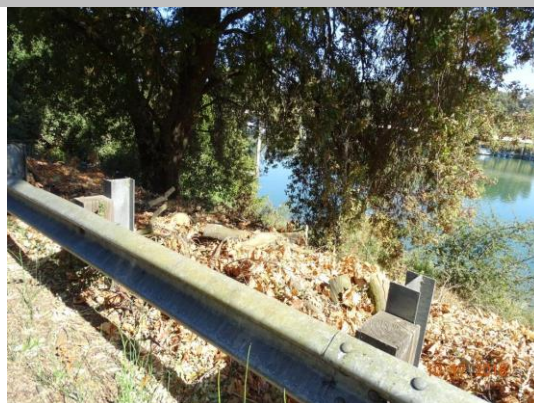
Photo 1 of 1 : FA\_2018\_RD0003\_25\_203\_20181018\_00309.jpg

LM Start	12.33	Rating **	M	Issue No.	203
LM End	12.33	Issue Type +	Ma	Location *	WS
Category	Earthen Levee			GPS Latitude/Longitude	
				Start	End
Item	Encroachments			38.250887 °	38.250887 °
				-121.512157 °	-121.512157 °
DWR ID	DWR_RD0003_02_f_2018_203				
Comment Code					
PR : Prunings					
Inspector Comment					
Remove prunings on waterside hinge point.

View of prunings on the water side shoulder (October 2018).

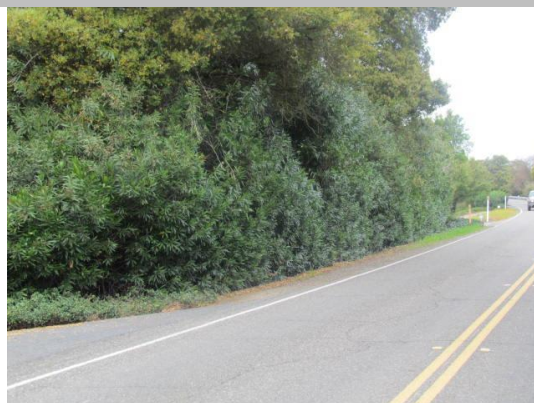
Photo 1 of 1 : FA\_2018\_RD0003\_25\_35\_20180925\_00034.jpg

LM Start	12.38	Rating **	U	Issue No.	35
LM End	12.43	Issue Type +	En	Location *	LS
Category	Earthen Levee			GPS Latitude/Longitude	
				Start	End
Item	Vegetation			38.251463 °	38.252200 °
				-121.512458 °	-121.512858 °
DWR ID	DWR_RD0003_02_s_2012_35				
Comment Code					
V6 : Landscaping					
Inspector Comment					
Landscaping blocking view of landside slope.

Looking northwest at dense landscaping on landside shoulder and slope.

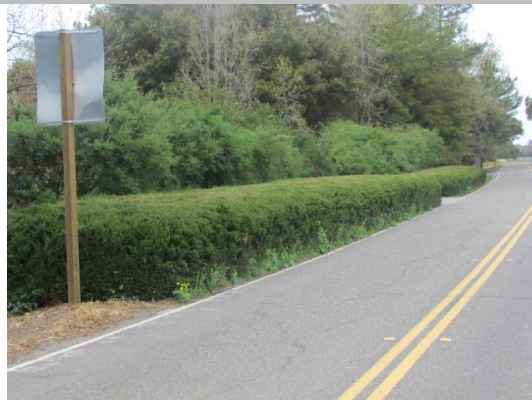
Photo 1 of 1 : FA\_2018\_RD0003\_25\_37\_20180925\_00035.jpg

LM Start	12.54	Rating **	U	Issue No.	37
LM End	12.63	Issue Type +	En	Location *	LS
Category	Earthen Levee			GPS Latitude/Longitude	
				Start	End
Item	Vegetation			38.253593 °	38.254590 °
				-121.513883 °	-121.514862 °
DWR ID	DWR_RD0003_02_s_2012_37				
Comment Code					
V6 : Landscaping					
Inspector Comment					
Dense landscaping on landside shoulder and slope.

Looking northwest at dense landscaping on landside shoulder and slope.

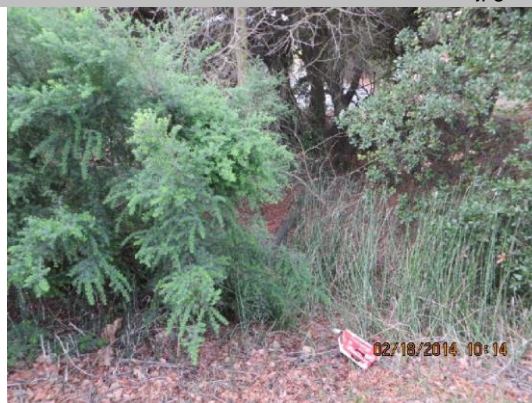
Photo 1 of 3 : UCIP\_FA\_2018\_40544\_55694.jpg

Comment Code					
Inspector Comment					
FS_ID:40544 DS_ID:22299 EP_NO: 1376 Repair Type: Non-Urgent Crossing Status: Found UCIP Comments: Pipe abandoned and should be done so properly. Pipe rusted through at various locations. FIELD_STRUCT_DESC: 12-inch steel irrigation discharge pipe through the levee, invert elevation 5 feet below the crown. Pump is missing from the waterside (WS) slope, and a steel plate is bolted over the end of the pipe. 42-inch concrete standpipe at the landside (LS) toe. 1.5-inch steel electrical conduit through the levee at the same location. (Plans for installing a vertical unit irrigation pumping plant and a 12-inch steel discharge pipe through the levee authorized under Permit No. 1376, 1949 - Joseph Gwerder Estate). [Additional Reference(s): DWR Levee Log, 1993. USACE Sacramento O&M Manual 104, February 1960, (RM 27.59)]. FS Date: 2/18/2014

Pipe visible on LS slope.

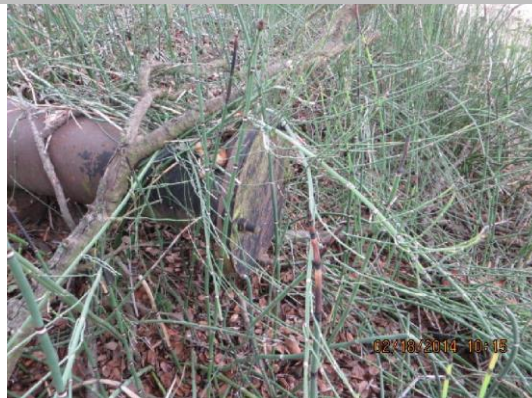
Photo 2 of 3 : UCIP\_FA\_2018\_40544\_55693.jpg

Steel plate bolted over pipe end on WS slope.

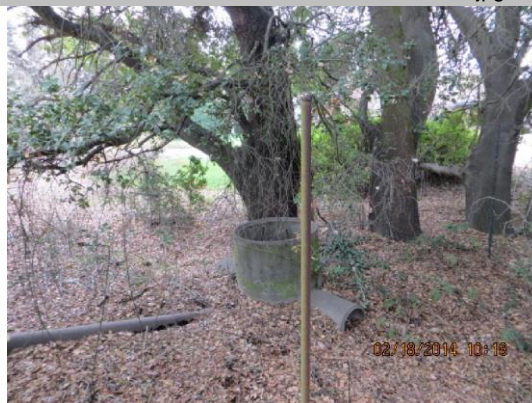
Photo 3 of 3 : UCIP\_FA\_2018\_40544\_55692.jpg

Concrete standpipe on LS toe.

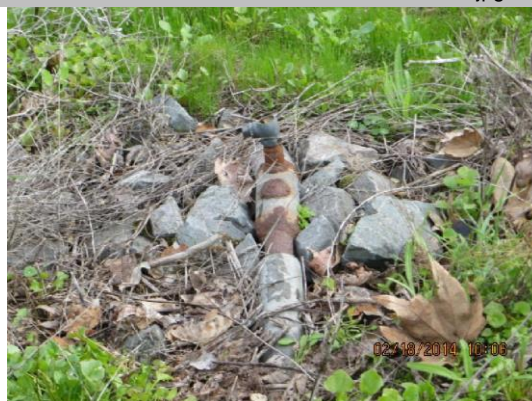
Photo 1 of 3 : UCIP\_FA\_2018\_30286\_55689.jpg

Comment Code						
Inspector Comment						
FS_ID:30286						
DS_ID:22300						
EP_NO: N/A						
Repair Type: Non-Urgent						
Crossing Status: Found						
UCIP Comments: Appears abandoned and if so should be done so properly. Vent broken off pipe on both shoulders.						
FIELD_STRUCT_DESC: 2.5-inch steel domestic water line through the levee, invert elevation 4.2 feet below the crown. (Gwerder). 1.5-inch steel irrigation pipe sleeved through the 2.5-inch pipe to a pump house off the landside (LS) toe. [Additional Reference(s): DWR Levee Log, 1993. USACE Sacramento O&M Manual 104, February 1960, (RM 27.71), galvanized iron pipe referenced].						
FS Date: 2/18/2014

Pipe visible on WS slope with broken vent.

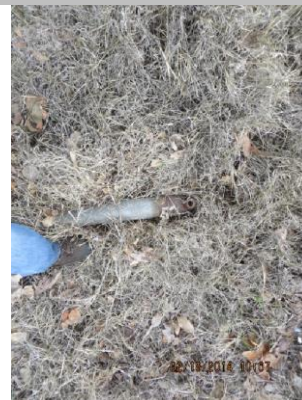
Photo 2 of 3 : UCIP\_FA\_2018\_30286\_55688.jpg

Pipe visible on LS slope with broken vent.

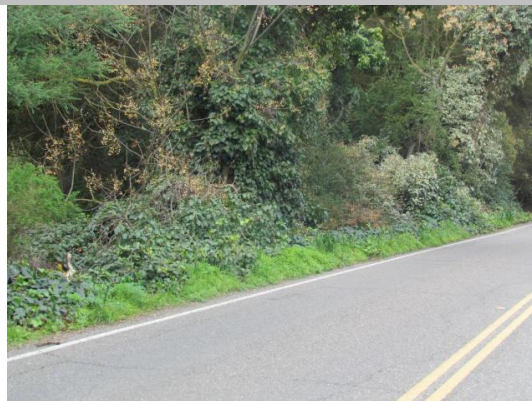
Photo 1 of 1 : FA\_2018\_RD0003\_25\_82\_20180925\_00066.jpg

LM Start	13.03	Rating **	M	Issue No.	82
LM End	13.06	Issue Type +	En	Location *	LS
Category	Earthen Levee			GPS Latitude/Longitude	
				Start	End
Item	Vegetation			38.258703 °	38.259003 °
				-121.520160 °	-121.520557 °
DWR ID	DWR_RD0003_02_s_2012_82				
Comment Code					
V6 : Landscaping					
Inspector Comment					
Dense landscaping blocking view of landside slope and toe.

Looking west at dense landscaping on landside shoulder and slope.

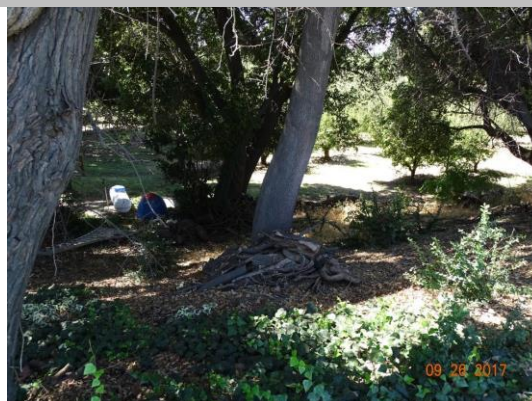
Photo 1 of 1 : FA\_2018\_RD0003\_25\_133\_20180925\_00095.jpg

LM Start	13.06	Rating **	M	Issue No.	133
LM End	13.06	Issue Type +	En	Location *	LS
Category	Earthen Levee			GPS Latitude/Longitude	
				Start	End
Item	Encroachments			38.258962 °	38.258962 °
				-121.520385 °	-121.520385 °
DWR ID	DWR_RD0003_02_s_2017_133				
Comment Code					
PR : Prunings					
Inspector Comment					
Debris and prunings at landside toe.

Looking southwest at the landside slope.

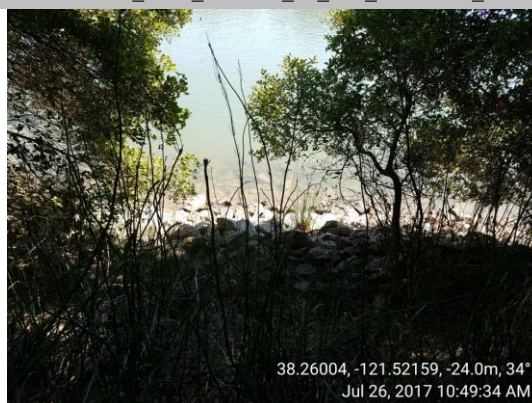
Photo 1 of 3 : FA\_2018\_RD0003\_25\_139\_20180925\_00105.jpg

LM Start	13.15	Rating **	A/W	Issue No.	139
LM End	13.17	Issue Type +	Ma	Location *	
Category	Supplemental			GPS Latitude/Longitude	
				Start	End
Item	2017 Storm Damage			38.260042 °	38.260219 °
				-121.521581 °	-121.521803 °
DWR ID	DWR_RD0003_02_f _ 2017_139				
Comment Code					
Inspector Comment					
Levee Evaluation Comments					
Description:District station 694+80 to 695+69, Sec. 27, 1. 5 N. R. 4 E., M.D.M. Approximately 89 linear feet of erosion and sloughing exists along the water side slope of the Sacramento River (Unit 2). The erosion commences approximately 1/2 of the way down the slope from the crown and extends into the rip rap.					
Site ID No:281					
Site Designation:LMA-107					
Repair Type: Erosion					
Rating:Area of Concern					
Field Date:7/26/2017					
Notes:

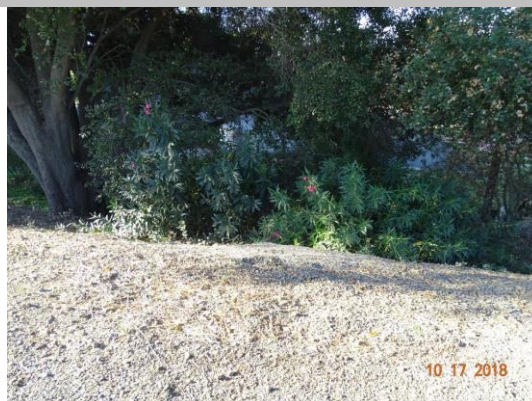
Photo 1 of 1 : FA\_2018\_RD0003\_25\_128\_20181018\_00291.jpg

LM Start	13.36	Rating **	M	Issue No.	128
LM End	13.36	Issue Type +	En	Location *	LS
Category	Earthen Levee			GPS Latitude/Longitude	
				Start	End
Item	Vegetation			38.262027°	38.262027°
				-121.524312°	-121.524312°
DWR ID	DWR_RD0003_02_f_2018_128				
Comment Code					
V6 : Landscaping					
Inspector Comment					
Oleanders blocking view of landside slope.

View of oleanders on the land side toe (October 2018).

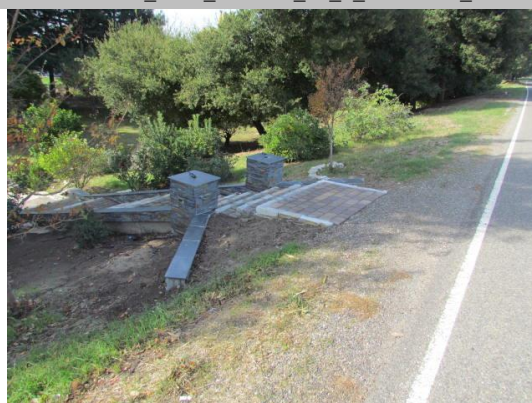
Photo 1 of 2 : FA\_2018\_RD0003\_25\_9\_20180925\_00009.jpg

LM Start	13.36	Rating **	M	Issue No.	9
LM End	13.36	Issue Type +	En	Location *	LS
Category	Earthen Levee			GPS Latitude/Longitude	
				Start	End
Item	Encroachments			38.262125 °	38.262125 °
				-121.524405 °	-121.524405 °
DWR ID	DWR_RD0003_02_s_2012_9				
Comment Code					
ST : Stairway					
Inspector Comment					
Landowner installed unauthorized stairs on landside slope. No permit on record.

Looking northwest at stairs on landside slope.

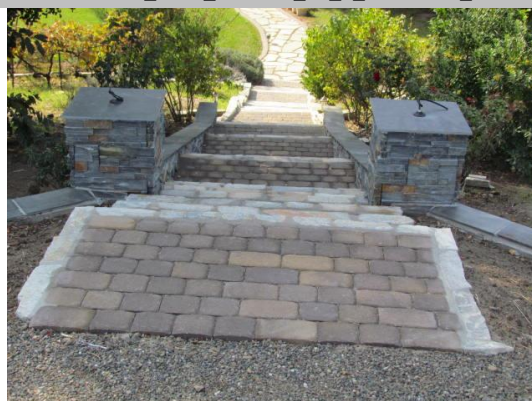
Photo 2 of 2 : FA\_2018\_RD0003\_25\_9\_20180925\_00010.jpg

Looking west at stairs on landside slope.

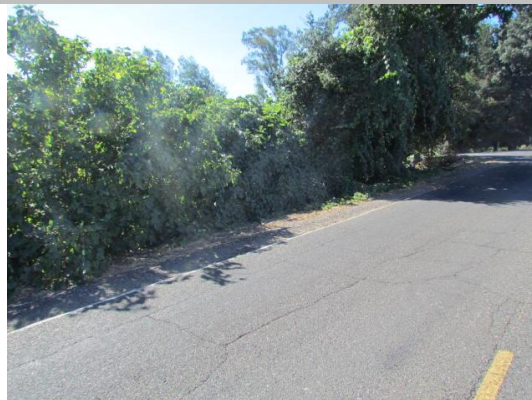
Photo 1 of 2 : FA\_2018\_RD0003\_25\_99\_20180925\_00080.jpg

LM Start	13.40	Rating **	M	Issue No.	99
LM End	13.40	Issue Type +	En	Location *	LS
Category	Earthen Levee			GPS Latitude/Longitude	
				Start	End
Item	Vegetation			38.262449°	38.262449°
				-121.524899°	-121.524899°
DWR ID	DWR_RD0003_02_f_2015_99				
Comment Code					
V6 : Landscaping					
Inspector Comment					
Figs trees and other plants blocking view of landside slope.

Looking westly at dense vegetation on landward shoulder and slope.  
(Spring 2016)

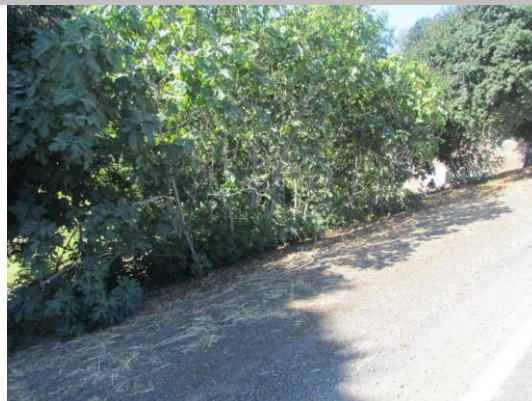
Photo 2 of 2 : FA\_2018\_RD0003\_25\_99\_20180925\_00081.jpg

Looking westly at fig trees on landward slope. (Fall 2016)

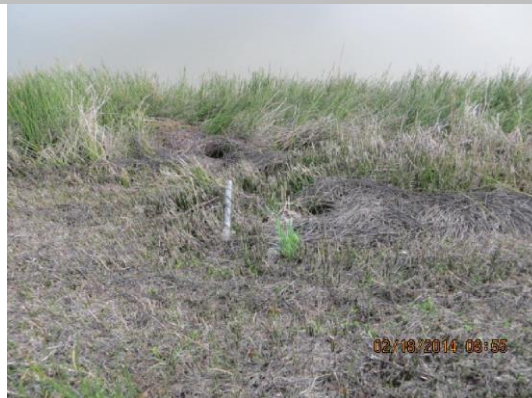
Photo 1 of 3 : UCIP\_FA\_2018\_41585\_55628.jpg

LM Start	13.70	Rating **	M	Issue No.	993	
LM End	13.70	Issue Type +	En	Location *		
Category	Supplemental			GPS Latitude/Longitude		
				Start	End	
Item	DWR UCIP Field Study			38.265474 °	38.265474 °	
				-121.528819 °	-121.528819 °	
DWR ID	22306					
Comment Code						
Inspector Comment						
FS_ID:41585						
DS_ID:22306						
EP_NO: N/A						
Repair Type: Non-Urgent						
Crossing Status: Found						
UCIP Comments: Steel plate broken and pipe open on WS slope. Pipe abandoned and should be done so properly.						
FIELD_STRUCT_DESC: *ABANDONED* 12-inch steel irrigation pipe through the levee, 6 feet below the crown. (Steel plate welded on the waterside [WS] end by USACE, Unit 15, in 1969). [Additional Reference(s): DWR Levee Log, 1993].						
FS Date: 2/18/2014

Pipe visible on WS slope.

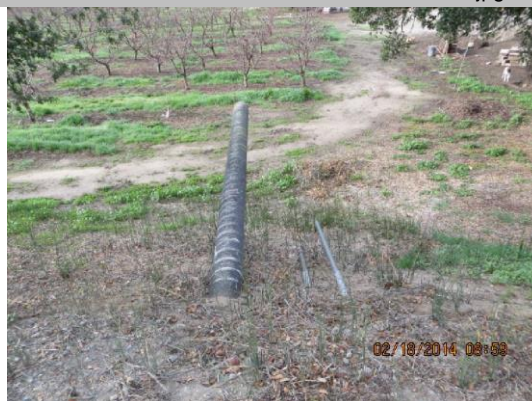
Photo 3 of 3 : UCIP\_FA\_2018\_41585\_55626.jpg

LM Start	13.70	Rating **	M	Issue No.	993 (cont)	
LM End	13.70	Issue Type +	En	Location *		
Category	Supplemental			GPS Latitude/Longitude		
				Start	End	
Item	DWR UCIP Field Study			38.265474 °	38.265474 °	
				-121.528819 °	-121.528819 °	
DWR ID	22306					
Comment Code						
Inspector Comment						
FS_ID:41585						
DS_ID:22306						
EP_NO: N/A						
Repair Type: Non-Urgent						
Crossing Status: Found						
UCIP Comments: Steel plate broken and pipe open on WS slope. Pipe abandoned and should be done so properly.						
FIELD_STRUCT_DESC: *ABANDONED* 12-inch steel irrigation pipe through the levee, 6 feet below the crown. (Steel plate welded on the waterside [WS] end by USACE, Unit 15, in 1969). [Additional Reference(s): DWR Levee Log, 1993].						
FS Date: 2/18/2014

Pipe visible on LS slope.

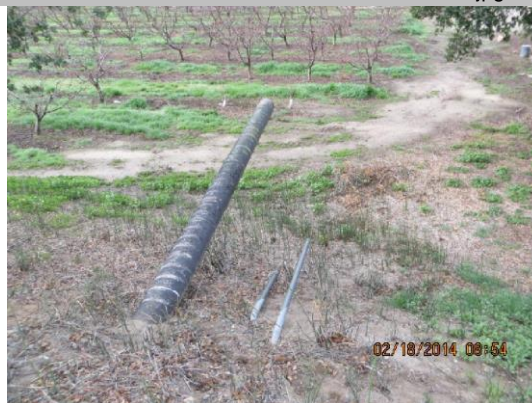
Photo 1 of 3 : UCIP\_FA\_2018\_30204\_55605.jpg

LM Start	13.70	Rating **	M	Issue No.	994
LM End	13.70	Issue Type +	En	Location *	
Category	Supplemental			GPS Latitude/Longitude	
				Start	End
Item	DWR UCIP Field Study			38.265479 °	38.265479 °
				-121.528825 °	-121.528825 °
DWR ID	22307				
Comment Code					
Inspector Comment					
FS_ID:30204					
DS_ID:22307					
EP_NO: N/A					
Repair Type: Non-Urgent					
Crossing Status: Found					
UCIP Comments: Abandoned and should be done so properly as it is open on both ends.					
FIELD_STRUCT_DESC: *ABANDONED* 2-inch electrical conduit of an unknown material through the levee, 5.5 feet below the crown. (Open on both ends by USACE, Unit 15, in 1969). [Additional Reference(s): DWR Levee Log, 1993].					
FS Date: 2/18/2014

Pipe visible at right on LS slope.

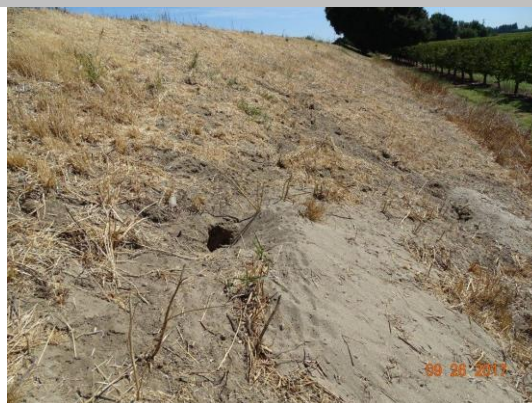
Photo 1 of 1 : FA\_2018\_RD0003\_25\_169\_20180925\_00142.jpg

LM Start	13.86	Rating **	A/W	Issue No.	169
LM End	13.86	Issue Type +	Ma	Location *	LS
Category	Earthen Levee			GPS Latitude/Longitude	
				Start	End
Item	Animal Control			38.267084 °	38.267084 °
				-121.530939 °	-121.530939 °
DWR ID	DWR_RD0003_02_f_2017_169				
Comment Code					
A1 : Exterminate rodents and backfill and compact or grout burrows.					
Inspector Comment

Looking southeast at the landside slope.

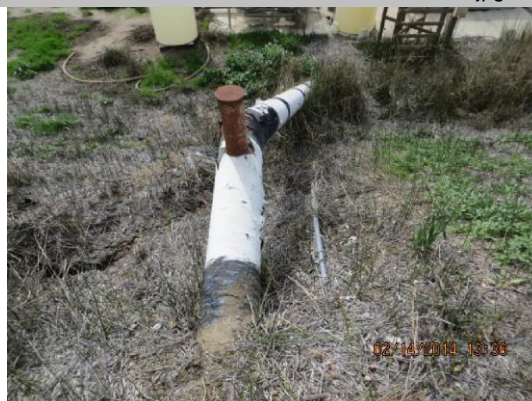
Photo 1 of 3 : UCIP\_FA\_2018\_30203\_55602.jpg

Comment Code						
Inspector Comment						
FS_ID:30203						
DS_ID:22308						
EP_NO: N/A						
Repair Type: Non-Urgent						
Crossing Status: Found						
UCIP Comments: Erosion next to pipe on LS slope.						
FIELD_STRUCT_DESC: 16-inch steel irrigation discharge pipe through the levee, 3 feet below the crown. 14-inch pipe sleeved through the 16-inch pipe and a 1.5-inch steel electrical conduit at the same location.						
Slant pump on the waterside (WS) slope and a filter plant at the landside (LS) toe. [Additional Reference(s): DWR Levee Log, 1993, referenced as 5.6 feet below the crown. USACE Sacramento O&M Manual 104, February 1960, (RM 28.91), referenced as invert elevation 5.6 feet below the crown].						
FS Date: 2/14/2014

Pipe, vent, and electrical conduit visible on LS slope.

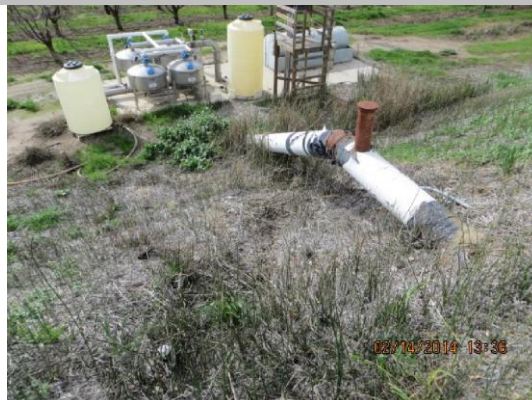
Photo 2 of 3 : UCIP\_FA\_2018\_30203\_55601.jpg

Erosion in foreground with pipe and filter plant in background.

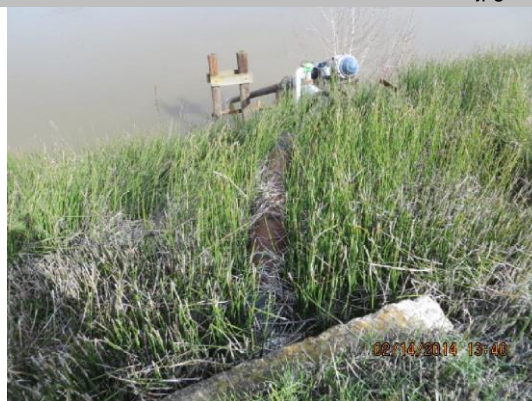
Photo 3 of 3 : UCIP\_FA\_2018\_30203\_55600.jpg

Item	DWR UCIP Field Study			38.267355 °		38.267355 °
				-121.531262 °		-121.531262 °
DWR ID	22308					
Comment Code						
Inspector Comment						
FS_ID:30203						
DS_ID:22308						
EP_NO: N/A						
Repair Type: Non-Urgent						
Crossing Status: Found						
UCIP Comments: Erosion next to pipe on LS slope.						
FIELD_STRUCT_DESC: 16-inch steel irrigation discharge pipe through the levee, 3 feet below the crown. 14-inch pipe sleeved through the 16-inch pipe and a 1.5-inch steel electrical conduit at the same location.						
Slant pump on the waterside (WS) slope and a filter plant at the landside (LS) toe. [Additional Reference(s): DWR Levee Log, 1993, referenced as 5.6 feet below the crown. USACE Sacramento O&M Manual 104, February 1960, (RM 28.91), referenced as invert elevation 5.6 feet below the crown].						
FS Date: 2/14/2014

Concrete headwall, pipe, and slantpump on WS slope.

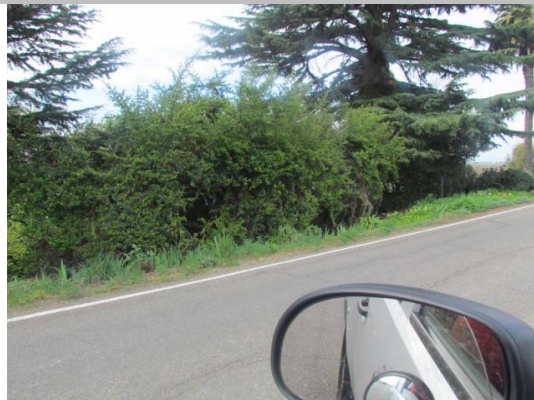
Photo 1 of 1 : FA\_2018\_RD0003\_25\_50\_20180925\_00038.jpg

LM Start	14.11	Rating **	M	Issue No.	50
LM End	14.17	Issue Type +	En	Location *	LS
Category	Earthen Levee			GPS Latitude/Longitude	
				Start	End
Item	Vegetation			38.269528 °	38.270113 °
				-121.534428 °	-121.535268 °
DWR ID	DWR_RD0003_02_s_2012_50				
Comment Code					
V6 : Landscaping					
Inspector Comment

Looking west at landscaping on landside slope.

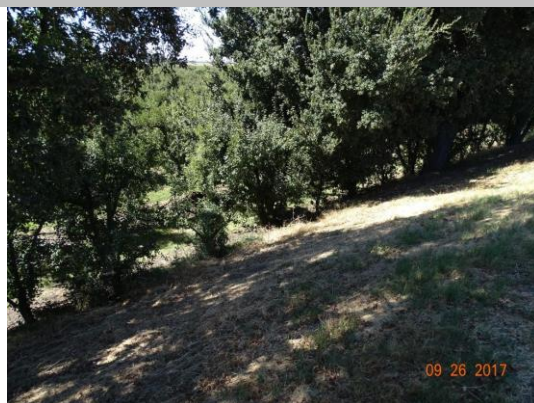
Photo 1 of 1 : FA\_2018\_RD0003\_25\_168\_20180925\_00141.jpg

LM Start	14.32	Rating **	M	Issue No.	168
LM End	14.40	Issue Type +	En	Location *	LS
Category	Earthen Levee			GPS Latitude/Longitude	
				Start	End
Item	Encroachments			38.271622 °	38.272350 °
				-121.537290 °	-121.538245 °
DWR ID	DWR_RD0003_02_f_2017_168				
Comment Code					
CR : Crops					
Inspector Comment					
Landowner has planted pear trees at the toe of the levee.

Looking northwest at the landside slope.

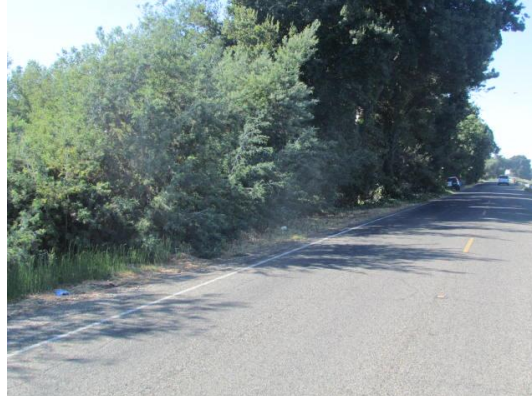
Photo 1 of 2 : FA\_2018\_RD0003\_25\_72\_20180925\_00051.jpg

LM Start	14.69	Rating **	U	Issue No.	72
LM End	14.84	Issue Type +	En	Location *	LS
Category	Earthen Levee			GPS Latitude/Longitude	
				Start	End
Item	Vegetation			38.275256 °	38.276857 °
				-121.542099 °	-121.543988 °
DWR ID	DWR_RD0003_02_s_2012_72				
Comment Code					
V6 : Landscaping					
Inspector Comment

Looking westly at dense landscaping on landward shoulder and slope.

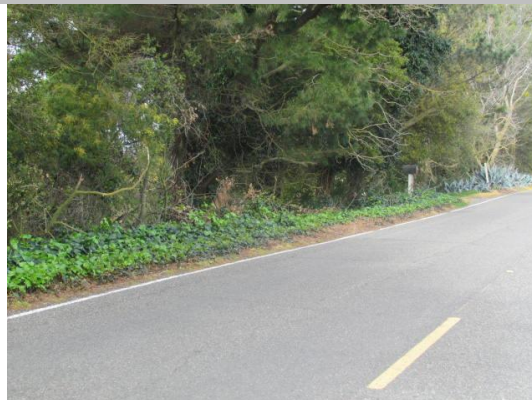
Photo 2 of 2 : FA\_2018\_RD0003\_25\_72\_20180925\_00052.jpg

LM Start	14.69	Rating **	U	Issue No.	72 (cont)	
LM End	14.84	Issue Type +	En	Location *	LS	
Category	Earthen Levee			GPS Latitude/Longitude		
				Start		End
Item	Vegetation			38.275256°		38.276857°
				-121.542099°		-121.543988°
DWR ID	DWR_RD0003_02_s_2012_72					
Comment Code						
V6 : Landscaping						
Inspector Comment

Looking northwest at dense landscaping on landside shoulder and slope.

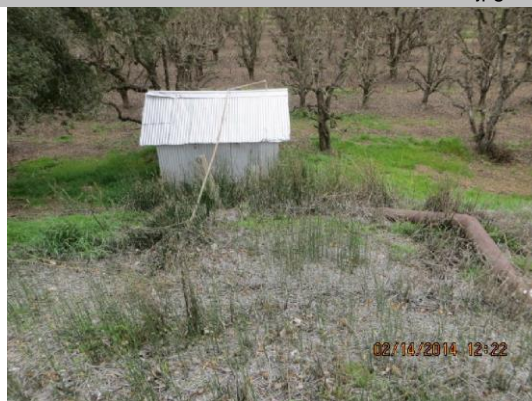
Photo 1 of 3 : UCIP\_FA\_2018\_30164\_55565.jpg

Comment Code						
Inspector Comment						
FS_ID:30164 DS_ID:22370 EP_NO: N/A Repair Type: Non-Urgent Crossing Status: Indicator Found UCIP Comments: Pipe abandoned and should be verified as having been done so properly. FIELD_STRUCT_DESC: *ABANDONED* 7-inch steel pipe of an unknown purpose through the levee, invert elevation 4.6 feet below the crown. (Green). 1.5-inch electrical conduit through the levee at the same location. Depression in-line with pump house on the waterside (WS) is a good indicator of the pipe location. 36-inch concrete standpipe at the landside (LS) toe. [DWR Levee Log, 1993. USACE Sacramento O&M Manual 104, February 1960, (RM 29.94)]. FS Date: 2/14/2014

Pumphouse on LS toe good indicator of abandoned pipe location.

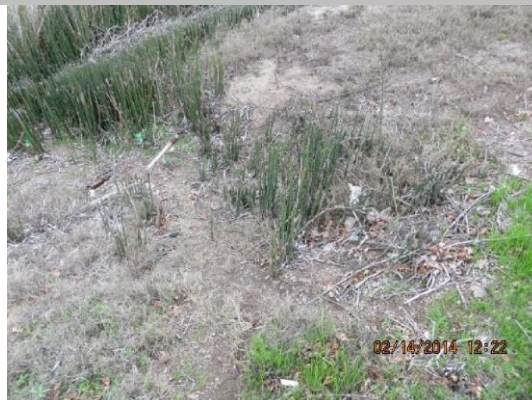
Photo 2 of 3 : UCIP\_FA\_2018\_30164\_55564.jpg

Depression on WS slope and electrical conduit at approximate location of pipe.

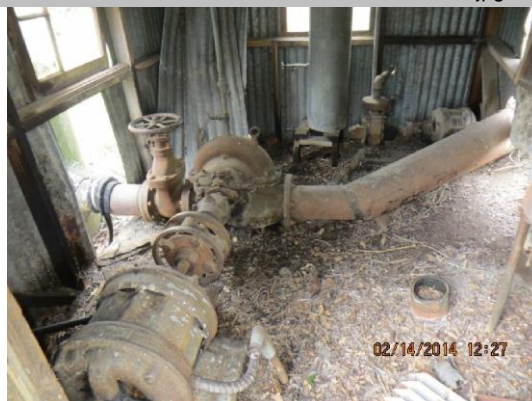
Photo 3 of 3 : UCIP\_FA\_2018\_30164\_55563.jpg

Item	DWR UCIP Field Study			38.277619 °		38.277619 °
				-121.544705 °		-121.544705 °
DWR ID	22370					
Comment Code						
Inspector Comment						
FS_ID:30164 DS_ID:22370 EP_NO: N/A Repair Type: Non-Urgent Crossing Status: Indicator Found UCIP Comments: Pipe abandoned and should be verified as having been done so properly. FIELD_STRUCT_DESC: *ABANDONED* 7-inch steel pipe of an unknown purpose through the levee, invert elevation 4.6 feet below the crown. (Green). 1.5-inch electrical conduit through the levee at the same location. Depression in-line with pump house on the waterside (WS) is a good indicator of the pipe location. 36-inch concrete standpipe at the landside (LS) toe. [DWR Levee Log, 1993. USACE Sacramento O&M Manual 104, February 1960, (RM 29.94)]. FS Date: 2/14/2014

Original pump now used for 10-inch.

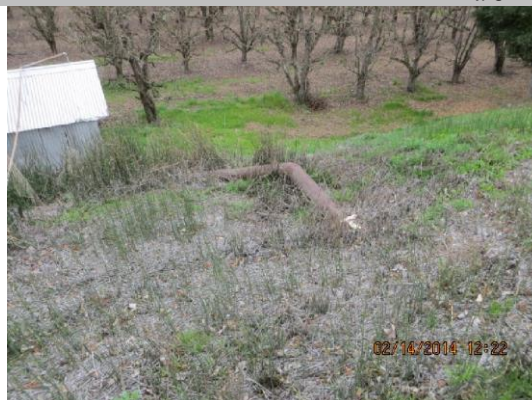
Photo 1 of 3 : UCIP\_FA\_2018\_30165\_55568.jpg

Comment Code					
Inspector Comment					
FS_ID:30165 DS_ID:22369 EP_NO: 919 Repair Type: Non-Urgent Crossing Status: Found UCIP Comments: Appears abandoned and if so should be done so properly. FIELD_STRUCT_DESC: 10-inch steel irrigation discharge pipe through the levee, invert elevation 3.8 feet below the crown. Pump and gate valve in a pump house at the landside (LS) toe. 2-inch filler pipe at the same location, 3 feet below the crown. (Plans for the installation of a 10-inch, 7-gauge welded steel pipe through the levee authorized under Permit No. 919, 1943 - Dell Kercheval). [Additional Reference(s): DWR Levee Log, 1993. USACE Sacramento O&M Manual 104, February 1960 (RM 29.94)]. FS Date: 2/14/2014

Pipe visible on LS slope.

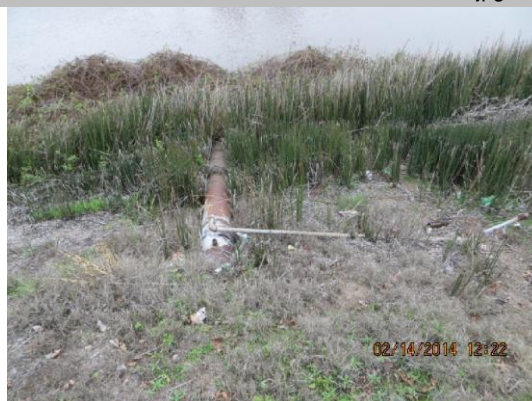
Photo 2 of 3 : UCIP\_FA\_2018\_30165\_55567.jpg

Item	DWR UCIP Field Study			38.277631°	38.277631°	
				-121.544718°	-121.544718°	
DWR ID	22369					
Comment Code						
Inspector Comment						
FS_ID:30165 DS_ID:22369 EP_NO: 919 Repair Type: Non-Urgent Crossing Status: Found UCIP Comments: Appears abandoned and if so should be done so properly. FIELD_STRUCT_DESC: 10-inch steel irrigation discharge pipe through the levee, invert elevation 3.8 feet below the crown. Pump and gate valve in a pump house at the landside (LS) toe. 2-inch filler pipe at the same location, 3 feet below the crown. (Plans for the installation of a 10-inch, 7-gauge welded steel pipe through the levee authorized under Permit No. 919, 1943 - Dell Kercheval). [Additional Reference(s): DWR Levee Log, 1993. USACE Sacramento O&M Manual 104, February 1960 (RM 29.94)]. FS Date: 2/14/2014

Pipe visible on WS slope and filler pipe visible.

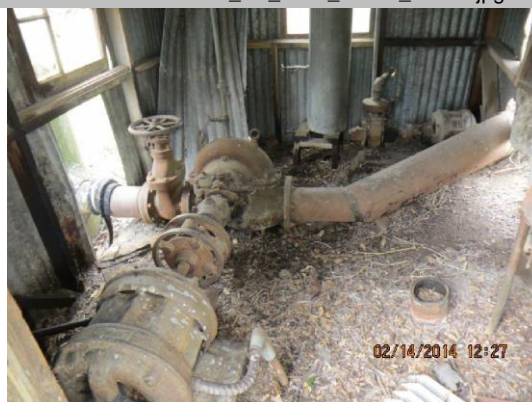
Photo 3 of 3 : UCIP\_FA\_2018\_30165\_55566.jpg

Pump and gate valve visible in pumphouse. Connection to concrete standpipe failing.

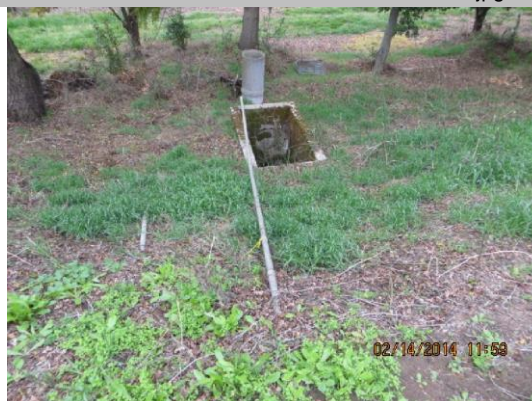
Photo 1 of 3 : UCIP\_FA\_2018\_53292\_55542.jpg

FS\_ID:53292  
DS\_ID:22371  
EP\_NO: N/A  
Repair Type: Urgent  
Crossing Status: Found  
UCIP Comments: 07/20/2018 Everything appears to be the same as last time. No changes have been made. No new pipe has been put in. Crossing remains "Urgent" because of the holes visible in 2014. (DWR UCIP - A. McDonald)07/06/2016 Heavy vegetation prevented visibility. Per RD0003 president David Robertson, WS erosion repaired last Spring. Could not fully see any repair work done. Need to return when vegetation cleared. Appears abandoned and if so should be done properly. (DWR UCIP - K. Fazel)02/14/2014 Pipe rusted through on WS slope. Appears abandoned and should be done so properly. Erosion of WS slope under pipe on WS toe. (DWR FPIIB - G. Wylie) FIELD\_STRUCT\_DESC: \*ABANDONED\* 12-inch steel irrigation discharge pipe through the levee, invert elevation 7 feet below the crown. Slant pump next to old pump house on the waterside (WS) slope. 2-inch filler pipe at the same location. 4-foot by 8-foot concrete distribution box and standpipe at the landside (LS) toe. (Plans to replace a 12-inch steel pipe through the levee authorized under Permit No. 7082, 1974 - Pacific Fruit Farms). Permit was canceled. Original pipe remains. [Additional Reference(s): DWR Levee Log, 1993. USACE Sacramento O&M Manual 104, February 1960, (RM 30.30)]. FS Date: 7/20/2018

Concrete distribution box on LS toe with electrical conduit visible.

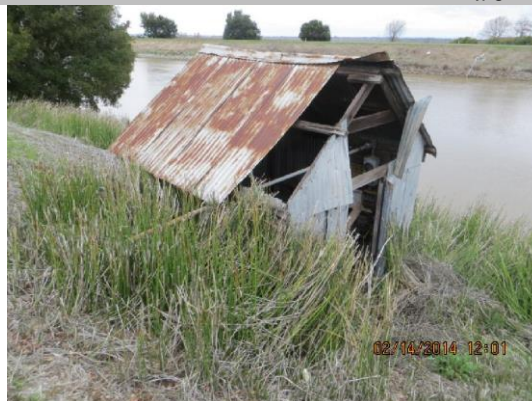
Photo 2 of 3 : UCIP\_FA\_2018\_53292\_55541.jpg

Pumphouse on WS slope next to slant pump.

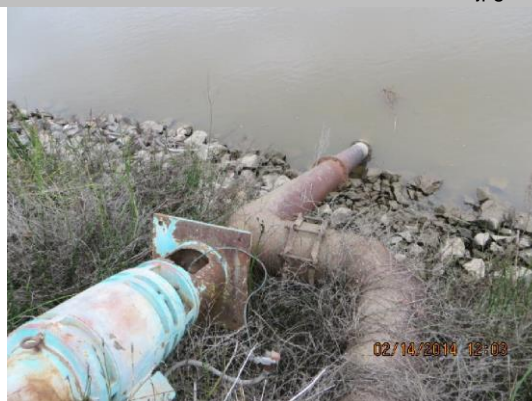
Photo 3 of 3 : UCIP\_FA\_2018\_53292\_55540.jpg

Item	DWR UCIP Field Study			38.281302 °	38.281302 °	
				-121.549338 °	-121.549338 °	
DWR ID	22371					
Comment Code						
Inspector Comment						
FS_ID:53292 DS_ID:22371 EP_NO: N/A Repair Type: Urgent Crossing Status: Found UCIP Comments: 07/20/2018 Everything appears to be the same as last time. No changes have been made. No new pipe has been put in. Crossing remains "Urgent" because of the holes visible in 2014. (DWR UCIP - A. McDonald)07/06/2016 Heavy vegetation prevented visibility. Per RD0003 president David Robertson, WS erosion repaired last Spring. Could not fully see any repair work done. Need to return when vegetation cleared. Appears abandoned and if so should be done properly. (DWR UCIP - K. Fazel)02/14/2014 Pipe rusted through on WS slope. Appears abandoned and should be done so properly. Erosion of WS slope under pipe on WS toe. (DWR FPIIB - G. Wylie) FIELD_STRUCT_DESC: *ABANDONED* 12-inch steel irrigation discharge pipe through the levee, invert elevation 7 feet below the crown. Slant pump next to old pump house on the waterside (WS) slope. 2-inch filler pipe at the same location. 4-foot by 8-foot concrete distribution box and standpipe at the landside (LS) toe. (Plans to replace a 12-inch steel pipe through the levee authorized under Permit No. 7082, 1974 - Pacific Fruit Farms). Permit was canceled. Original pipe remains. [Additional Reference(s): DWR Levee Log, 1993. USACE Sacramento O&M Manual 104, February 1960, (RM 30.30)]. FS Date: 7/20/2018

Slant pump on WS slope.

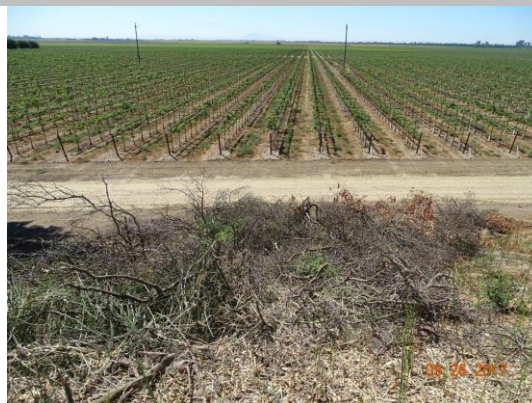
Photo 1 of 3 : FA\_2018\_RD0003\_25\_134\_20180925\_00096.jpg

LM Start	15.37	Rating **	M	Issue No.	134
LM End	15.37	Issue Type +	Ma	Location *	LS
Category	Earthen Levee			GPS Latitude/Longitude	
				Start	End
Item	Encroachments			38.282243 °	38.282243 °
				-121.550917 °	-121.550917 °
DWR ID	DWR_RD0003_02_s_2017_134				
Comment Code					
PR : Prunings					
Inspector Comment					
Large fallen tree on landside slope. Large tree removed, prunings remain on slope.

Looking southwest at the landside slope.

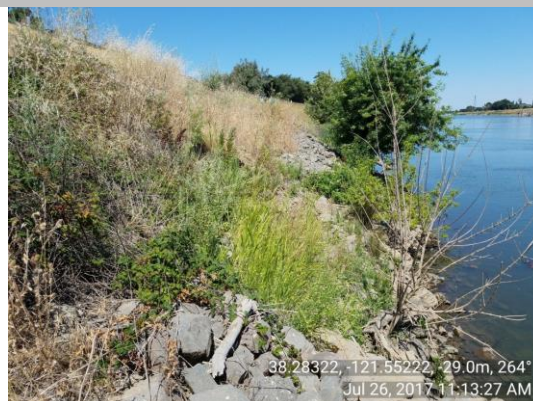
Photo 1 of 3 : FA\_2018\_RD0003\_25\_149\_20180925\_00120.jpg

LM Start	15.46	Rating **	A/W	Issue No.	149
LM End	15.47	Issue Type +	Ma	Location *	
Category	Supplemental			GPS Latitude/Longitude	
				Start	End
Item	2017 Storm Damage			38.283119 °	38.283172 °
				-121.552250 °	-121.552347 °
DWR ID	DWR_RD0003_02_f_2017_149				
Comment Code					
Inspector Comment					
Levee Evaluation Comments					
Description:District station 816+64 to 816+97, Sec. 16, T. 5 N. R. 4 E., M.D.M. Approximately 33 linear feet of erosion exists along the water side slope of the Sacramento River (Unit 2). The erosion commences approximately 1/2 ofthe way down the slope from the crown and extends into the rip rap. A section of rip rap has eroded away in this location.					
Site ID No:283					
Site Designation:LMA-109					
Repair Type: Erosion					
Rating:Area of Concern					
Field Date:7/26/2017					
Notes:

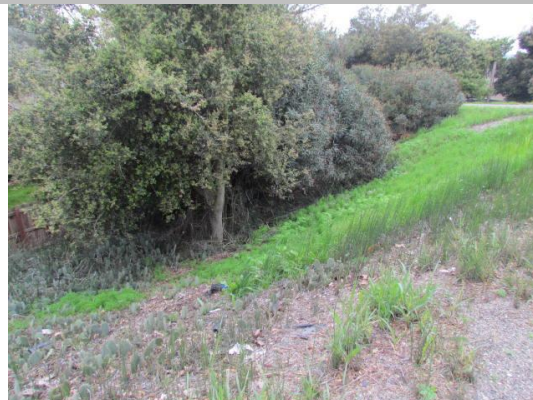
Photo 1 of 1 : FA\_2018\_RD0003\_25\_94\_20180925\_00076.jpg

LM Start	15.47	Rating **	U	Issue No.	94
LM End	15.47	Issue Type +	En	Location *	LS
Category	Earthen Levee			GPS Latitude/Longitude	
				Start	End
Item	Vegetation			38.283050 °	38.283050 °
				-121.552506 °	-121.552506 °
DWR ID	DWR_RD0003_02_s_2013_94				
Comment Code					
V6 : Landscaping					
Inspector Comment					
Dense landscaping on landside slope and toe.

Looking northwest at landscape at landward toe.

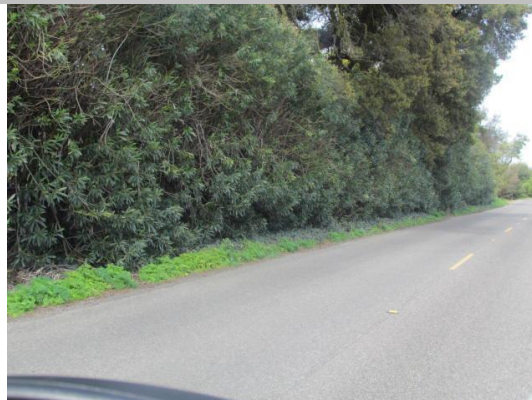
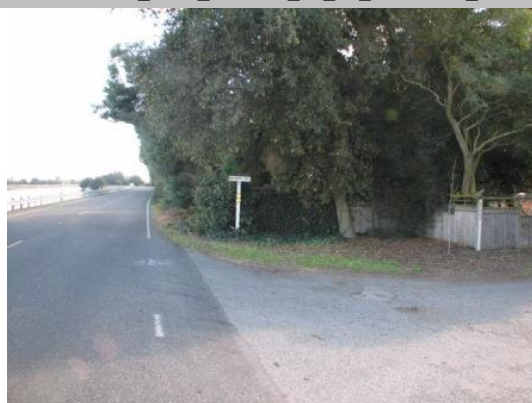
Looking northwest at dense landscaping on landside shoulder and slope.

Looking southeast at landscaping on levee slope and toe obstruct access and visibility.

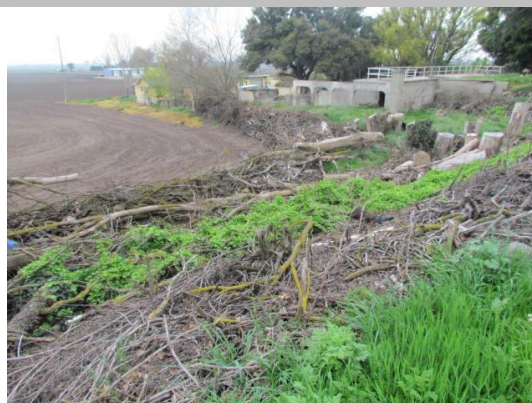
Photo 2 of 2 : FA\_2018\_RD0003\_25\_144\_20180925\_00116.jpg

LM Start	15.61	Rating **	U	Issue No.	144 (cont)	
LM End	15.61	Issue Type +	En	Location *	LS	
Category	Earthen Levee			GPS Latitude/Longitude		
				Start		End
Item	Encroachments			38.284393 °	38.284393 °	
				-121.554319 °	-121.554319 °	
DWR ID	DWR_RD0003_02_f_2015_144					
Comment Code						
PR : Prunings						
Inspector Comment						
Prunings piled on landside slope and toe along with tree stumps.

Looking southwest at prunings on landward slope and toe. (Spring 2016)

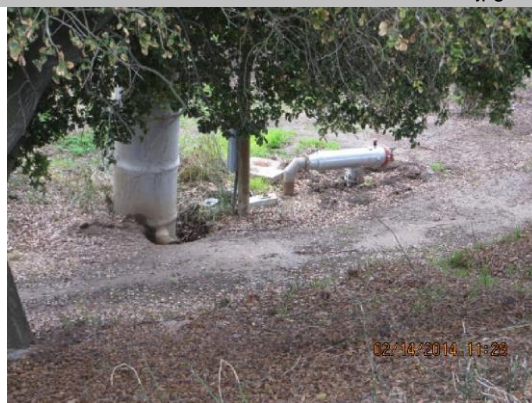
Photo 1 of 3 : UCIP\_FA\_2018\_30084\_55485.jpg

Comment Code						
Inspector Comment						
FS_ID:30084 DS_ID:22334 EP_NO: 2137 Repair Type: Non-Urgent Crossing Status: Found UCIP Comments: Appears abandoned and if so should be done so properly. Leak apparent at pipe connection to concrete standpipe at LS toe. Good candidate for video inspection. FIELD_STRUCT_DESC: 12-inch steel irrigation discharge pipe through the levee, invert elevation 9 feet below the crown. Slant pump on the waterside (WS) slope. 44-inch concrete standpipe at the landside (LS) toe. 1.5-inch electrical conduit through the levee at the same location. Filter plant at the LS toe. (Plans for the installation of a 12-inch irrigation pipe through the levee authorized under Permit No. 2137, 1955 - Pacific Fruit Exchange). [Additional Reference(s): DWR Levee Log, 1993, 14-inch pipe referenced, 6.5 feet below the crown. USACE Sacramento O&M Manual 104, February 1960, (RM 30.76)]. FS Date: 2/14/2014

Concrete standpipe, filter plant, power pole and meter on LS toe.

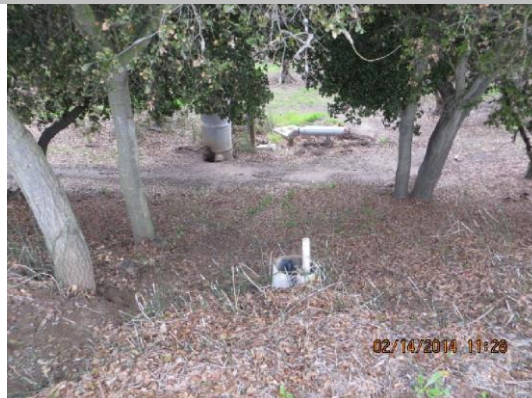
Photo 2 of 3 : UCIP\_FA\_2018\_30084\_55484.jpg

Siphon breaker on LS shoulder.

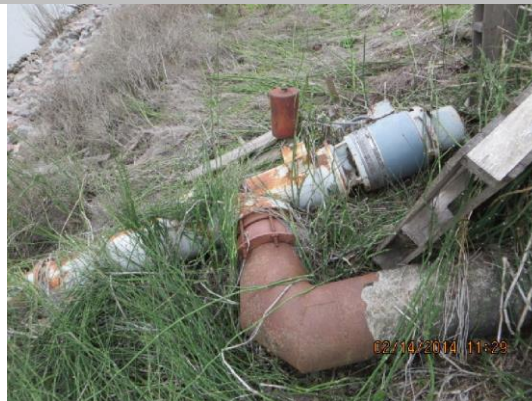
Photo 3 of 3 : UCIP\_FA\_2018\_30084\_55483.jpg

Slant pump on WS slope.

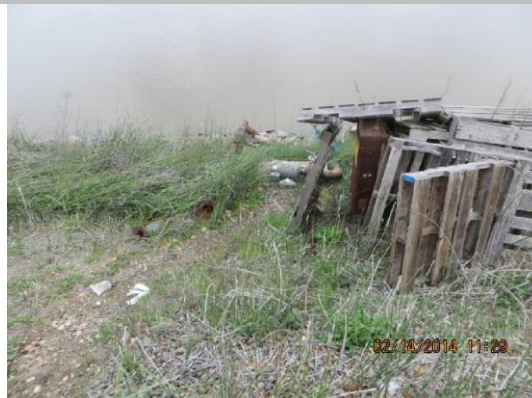
Photo 1 of 3 : UCIP\_FA\_2018\_30083\_55482.jpg

LM Start	15.71	Rating **	M	Issue No.	1001	
LM End	15.71	Issue Type +	En	Location *		
Category	Supplemental			GPS Latitude/Longitude		
				Start	End	
Item	DWR UCIP Field Study			38.285500 °	38.285500 °	
				-121.555635 °	-121.555635 °	
DWR ID	22375					
Comment Code						
Inspector Comment						
FS_ID:30083 DS_ID:22375 EP_NO: 7356 Repair Type: Non-Urgent Crossing Status: Found UCIP Comments: Pipe debris on WS slope. FIELD_STRUCT_DESC: 10-inch steel irrigation discharge pipe through the levee, 6.5 feet below the crown. 8-inch pipe on the landside (LS) slope. 6-inch pipe on the waterside (WS) slope. Pump and gate valve on the WS slope. (Plans to install a 6-inch pipe and pump on the WS slope of the levee authorized under Permit No. 7356, 1971 - Pacific Fruit Farms. USACE, Unit No. 15, 1969). [Additional Reference(s): DWR Levee Log, 1993]. FS Date: 2/14/2014

Pump on WS slope next to slant pump.
